# High Efficiency Hot Water Systems

## The Counter Restaurant San Mateo, CA

### Delivering Hot Water Efficiently

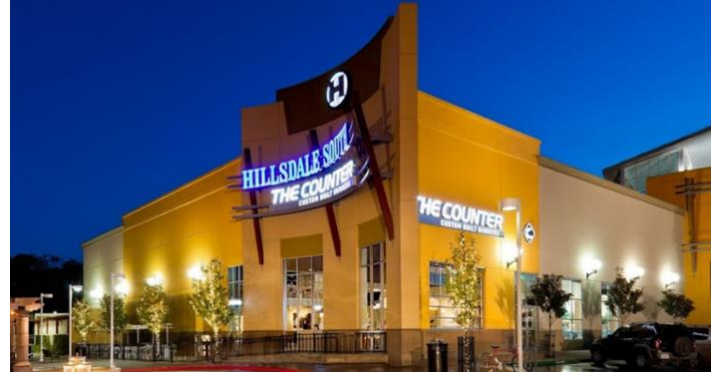
### Annual Operating Costs

Original System

\$24,100
Replacement System

\$17,900

Based on utility rates of \$34/HCF, \$0.17/kWh, \$1.10/therm  
Based on 365 days/year operation

Before	After	Savings
Water (HCF/y)	400	275	125
Gas (therms/y)	2,650	600	2,050
Electricity (kWh/y)	44,290	46,310	-2,020
Annual Cost	\$24,100	\$17,900	\$6,200

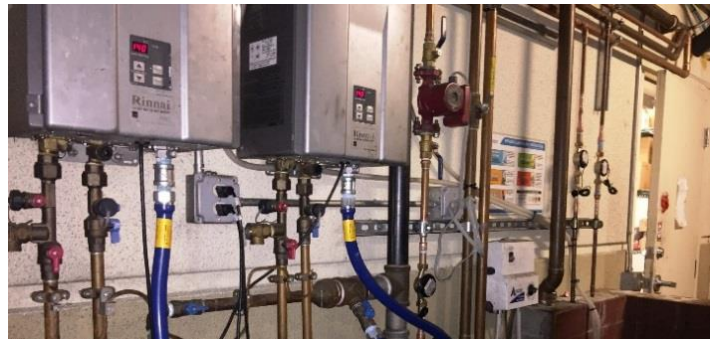
All the hot water piping throughout the building was uninsulated as shown in the picture of the garage where the tankless water heaters were located.

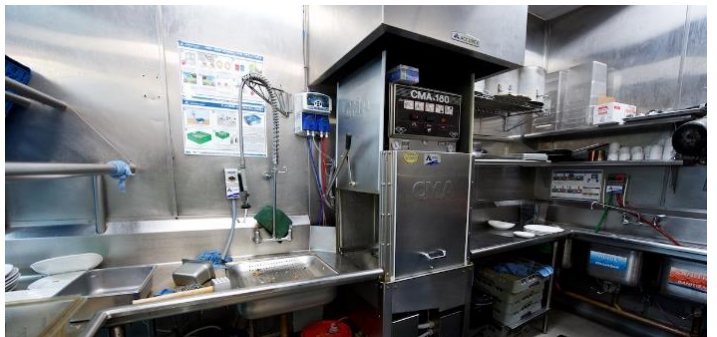
The picture of the dishroom shows the pre-rinse sprayer, dishmachine, and a 3-compartment sink. The dishroom accounted for 73% of the system's hot water use.

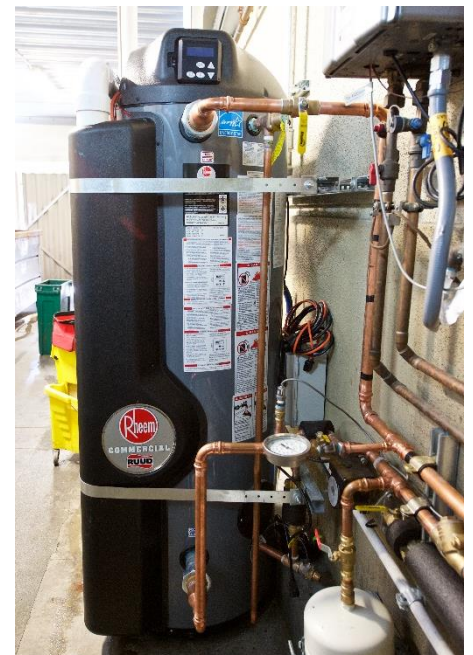
*Demand Control Circulator Pump with Motion Detector*

The continuous recirculation system was replaced with an **ACT D'MAND** circulation system which relies on a motion sensor in the kitchen and inline temperature sensor at the last fixture before the return line in order to circulate hot water only when the facility required it.

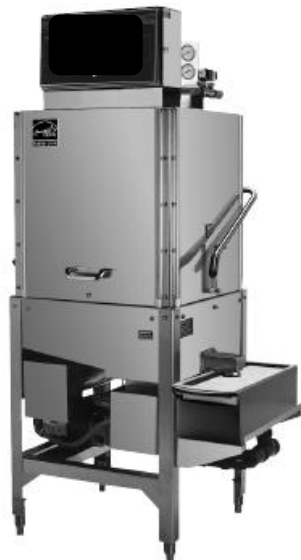
### Original:

Water Use Per Rack  
 Rated: 0.96 gal  
 Measured: 1.54 gal

Energy Use Per Rack  
 Gas: 1,360 Btu  
 Electricity: 0.48 kWh  
 Total: 2,990 Btu

Racks per Day: 233  
 Annual Cost: \$14,100

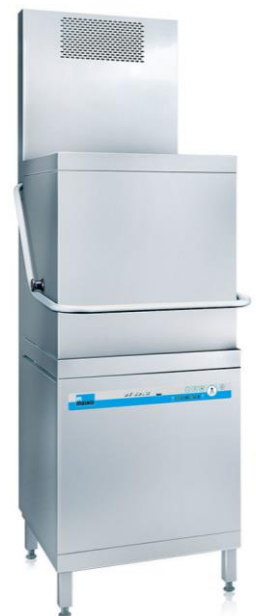
### New:

Water Use Per Rack  
 Rated: 0.74 gal  
 Measured: 0.71 gal

Energy Use Per Rack  
 Gas: 0 Btu  
 Electricity: 0.51 kWh  
 Total: 1,750 Btu

Racks per Day: 224  
 Annual Cost: \$9,900  
 Savings: \$4,200

The replacement dishmachine only required a cold-water supply, which allowed it to operate independent of the central HWS. The dishmachine was responsible for most of hot water savings associated with the new system—resulting in an average of 200 gallons saved daily with almost a 60% reduction in dishmachine water use. The dishmachine replacement saved the facility \$4,200 per year in utility costs!

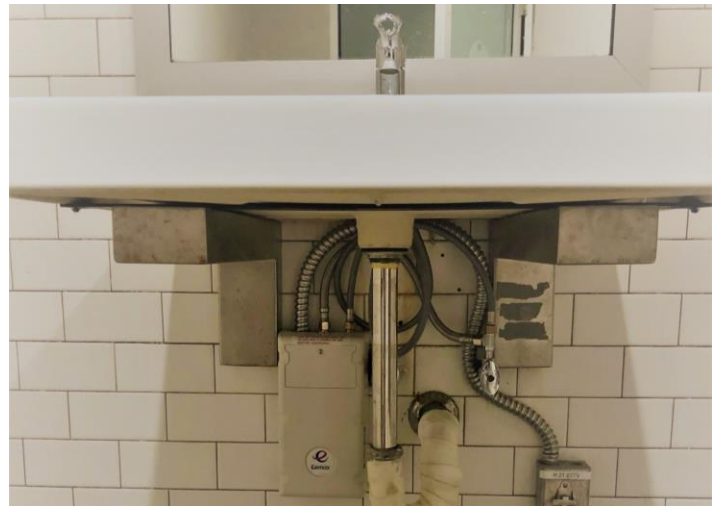
The Eemax unit pictured below is able to respond rapidly and provide 100°F water in 5 seconds from a cold start to ensure users have hot water to wash and rinse hands.

*Lavatory Point of Use Heater with instrumentation*

The research showed that almost all users of the single handle faucet in the restrooms choose the center flow position, which provides roughly equal flow of 0.25 gpm water from both the cold and hot water line at full flow. This ultra-low flow rate is problematic for most centralized systems, since it is difficult to deliver hot water present in the recirculation loop through the branch line in time. It is also problematic of most POU electric water heaters that have activation rates from 0.3 to 0.5 gpm. In fact, only two tankless POU heater model lines out of over 20 on the market meet the 0.2 gpm activation flow rate recommended for acceptable hot water delivery performance at hand sinks with 0.5 gpm faucet aerators installed. More information is available on qualifying models in the Commercial Kitchen HWS Design Guide which is located on the project webpage using the webpage link shown in the lower right column.
